Building site visit Report
Constructing Architect Education
2. Semester International. Class: 13bk2ena the Deadline: 02 June 2014
Group number 2. Asia, Daniels, Paulius and Ahsan

*Building site Report
Øster Parkvej.....
8270 Højberg Århus*

Inspection Report 1

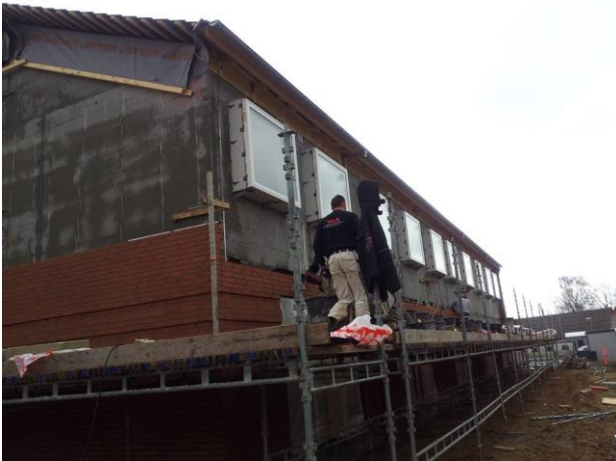
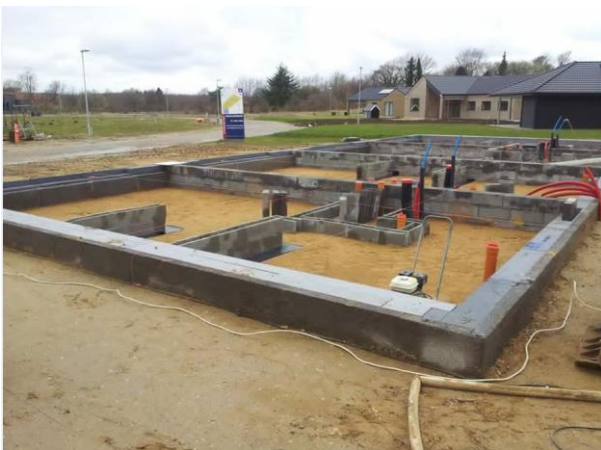
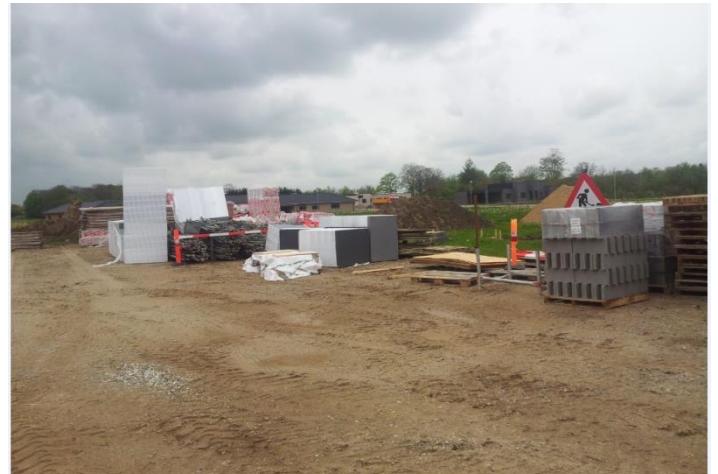
The pictures are illustrating the company's quality work according to BR10. The site looks very clean and clear, the materials are covered and protected from damage of rain, dust, etc. We can see that there is a wide area and the materials are placed far from the building area, from roads, and footpaths. The open and wide area can protect the neighbours from noises which come from the building site.

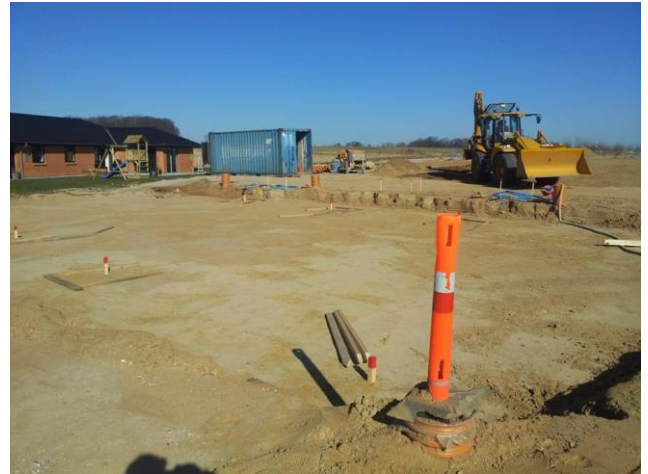
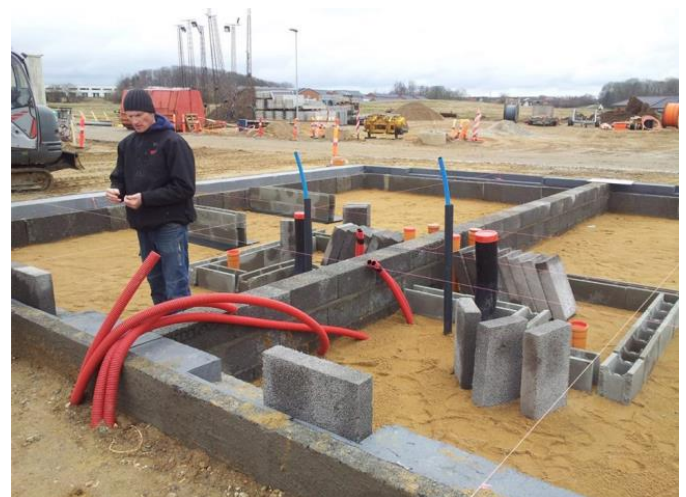
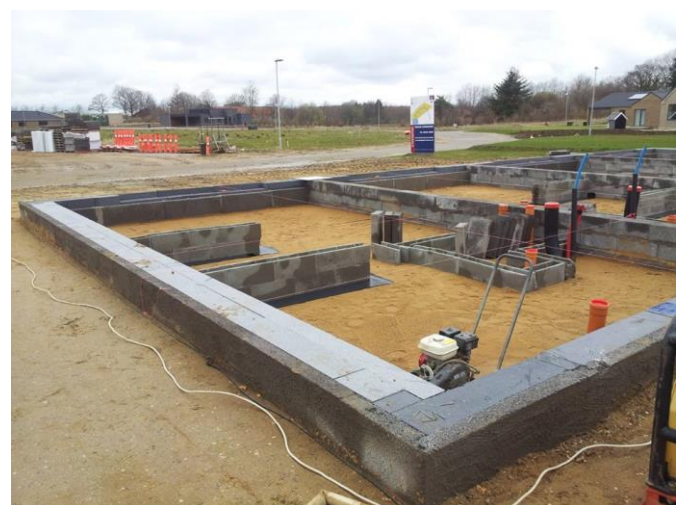
The foundation has the same width as the wall above will have and it will have symmetrically placed on to of foundation. We can see the placement of a perimeter drain and a inspection chamber. They donnot use the capilliary breaking layer because they tested the ground and apperantly it donnot have water at all. The perimeter drain is done and it is covered by soil and it is necessary to connect the inspection chamber with the perimeter drain.

Everything in the construction is done according to SBI and building regulation foundation. In figure 8 SBI page 13 says. Regarding external wall foundations, frost-free depth is usually 0.9 m below the surface.

The foundation is made according to SBI When I read the SBI direction 189 page 11 it was matching the foundation of this building.

We can see on the pictures the spaces for the windows and door the insulation and the installation pips. The terrine construction will be done next week.

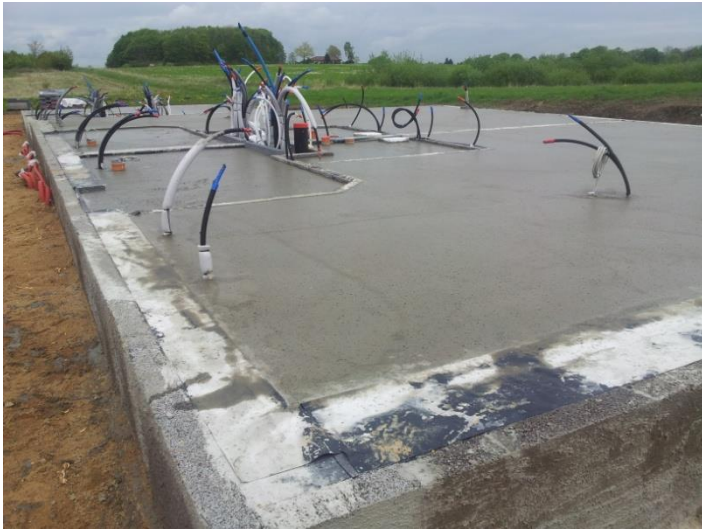
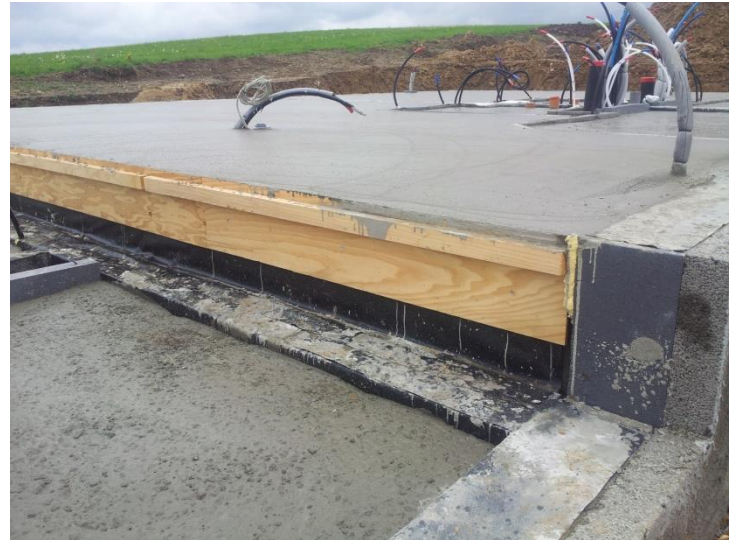
The pictures illustrate the terrain construction with casted concrete, radon protection placement, destruct heating pips, drainage pipes, ventilation pipes, insulation thickness and leca blocks to the level of the coasted concrete on the terrain.

The ground supported floor is resting directly on the ground. Ground supported floors is insulated against ingress of moisture and loss of heat. Also they are sufficiently sealed in order to prevent the ingress of air containing radon (from the subsurface).

In the inspection report it is mentioned that they had a radon protection around the foundation, after reading in the SBI I can conclude that they have placed it according to the guidelines, so when they cast the concrete it will be bended down and it can lead out radon gasses that might come up from the ground.

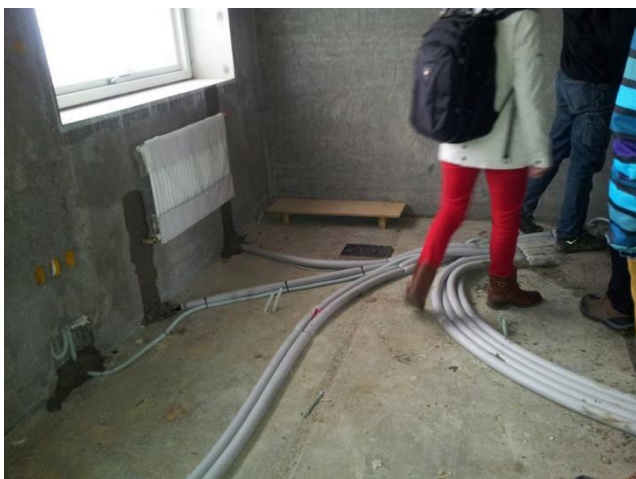
The picture illustrates the installation of radiator. As we can see that the radiator is placed under the window and the pips are covered that the water is not getting cold till it reaches the radiator, we can see 2 pips which connected to the radiator the hot water comes from one side and go out again from another side.

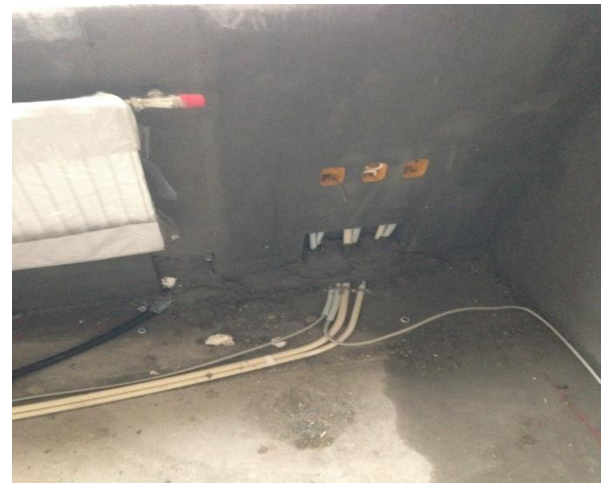
Here we can see the electricity installation of sockets and switches for the house the wires are covered to prevent from damage and in case of changing the wires it will be easy to change the sockets and electricity installation for the house was also according to BR10 where it says 1 socket for each 4 square meter.

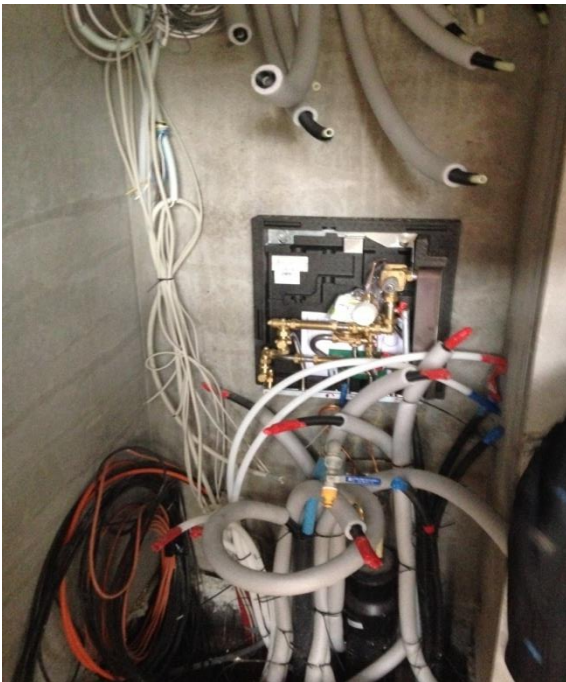
The shaft is placed in the entrance of the ground floor where all installations are connected to the shaft and the pips are divided to different parts of the house, the shaft base is in the ground floor and there is only a small hole in the first floor partition where the pips for radiators and wire for electricity comes out.

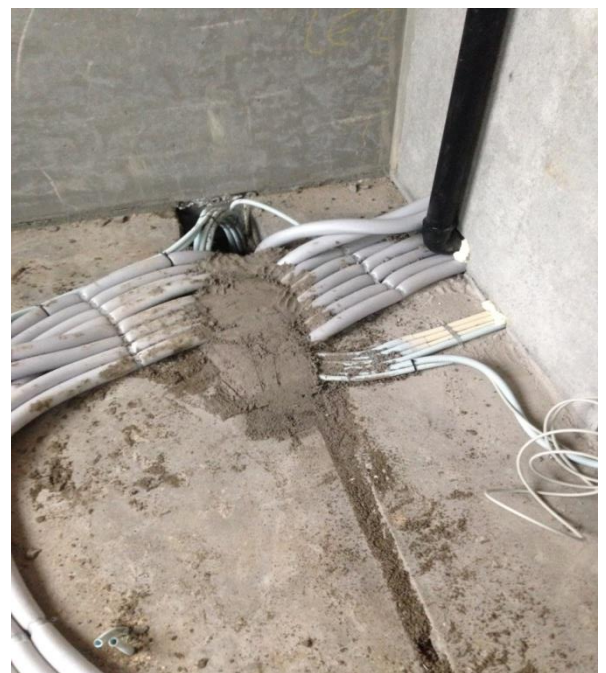
Her we can see that for the first floor we don't have shaft only a hole where the pips come and then the hole is covered by mortar. When the installation is finished all the installation cables and pipes will be hidden under the flooring.

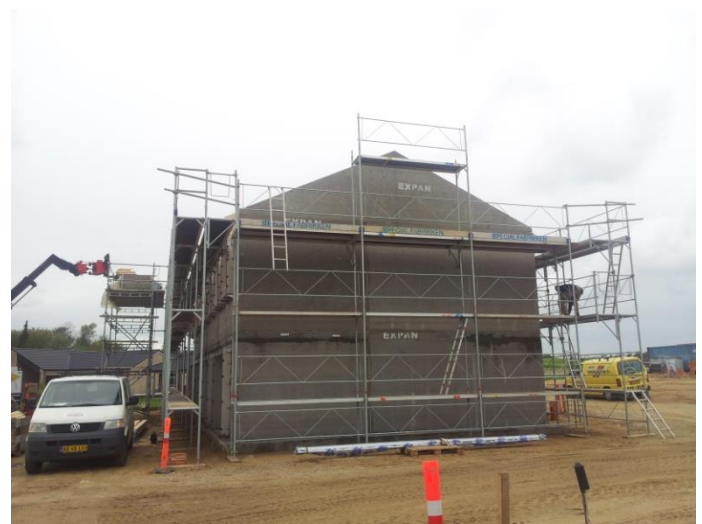
The first picture illustrate the concrete inner leaf of 100 mm which is the load carrying part of the construction it lays on the foundation over the damp proof and radon protection they use expand prefabricated concrete

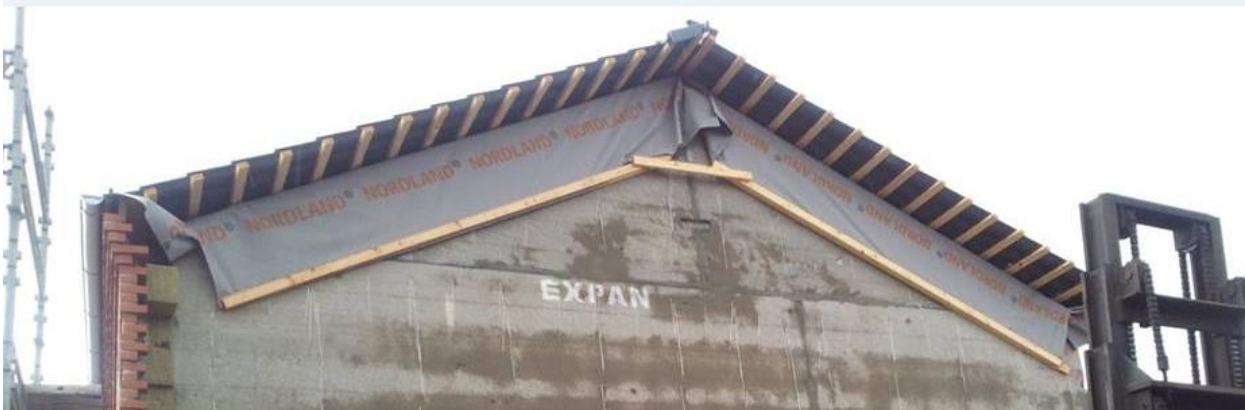
The pictures shows the external part of the roof where we can see the slops, which has created a attic the damp proof membrane is a diffusion open. The membrane is stretched and tight to two sides of gables to to protected it from blowing of the wind and water d it allows moisture go out.

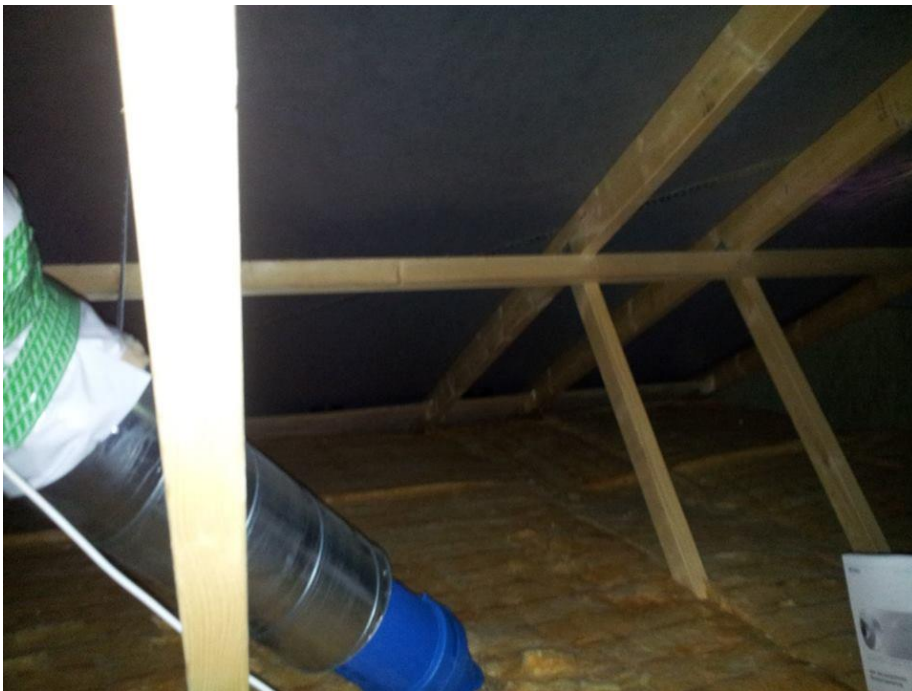
We climbed up to the attic we saw inside of the attic above the ceiling, here we can see the trusses and rafters which carry the load of the roof,mineral wool is placed on top of the ceiling.

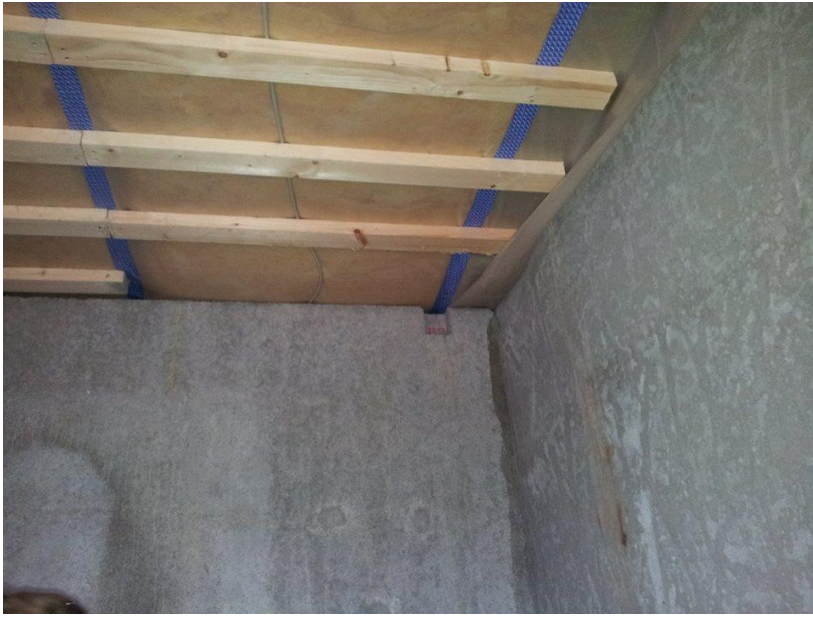
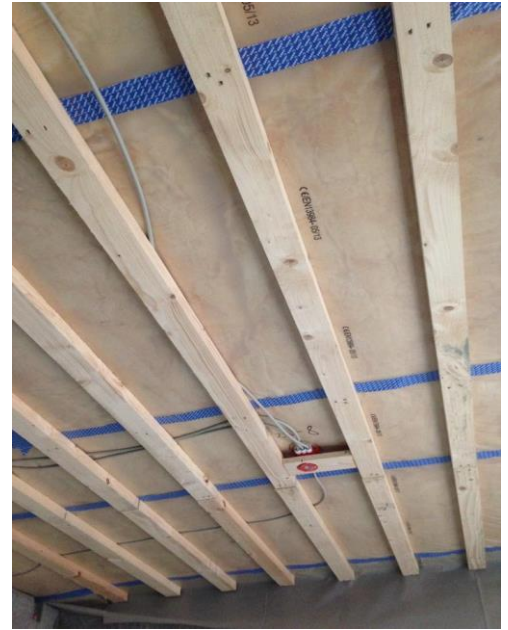
These two pictures are taken from inside. Here you can see a plastic membrane, wooden joist, and electrical installation. On the bottom of the joist will be fixed ceiling cladding.
