Building site visit Report
Constructing Architect Education
2. Semester International. Class: 13bk2ena the Deadline: 02 June 2014
Group number 2. Asia, Daniels, Paulius and Ahsan

*Building site Report
Øster Parkvej.....
8270 Højberg Århus*

Inspection Report 1

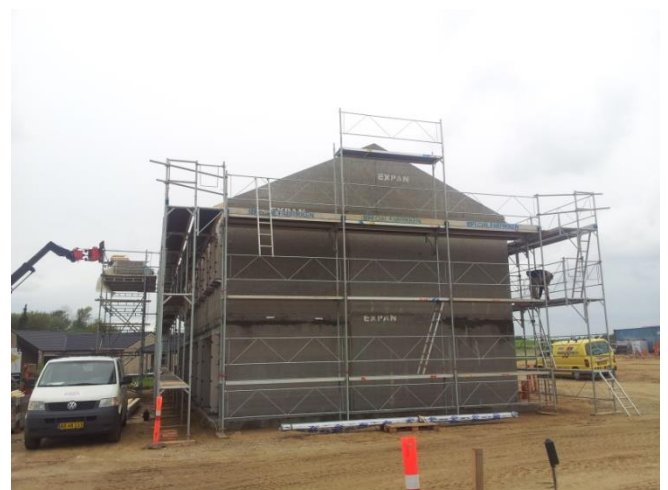
We think that the construction site has been very clean and the employers are very experienced they were respecting the BR regulation. All their materials for the building were covered professionally according BR 2010 and protected from moisture, rain, dust etc

The pictures are illustrating the company's quality work according to BR10. The site looks very clean and clear, the materials are covered and protected from damage of rain, dust, etc. We can see that there is a wide area and the materials are placed far from the building area, from roads, and footpaths. The open and wide area can protect the neighbours from noises which come from the building site.
