Moisture report

Business Academy Aarhus

Architectural Technology and Construction Management

13bk2ena, group no 2

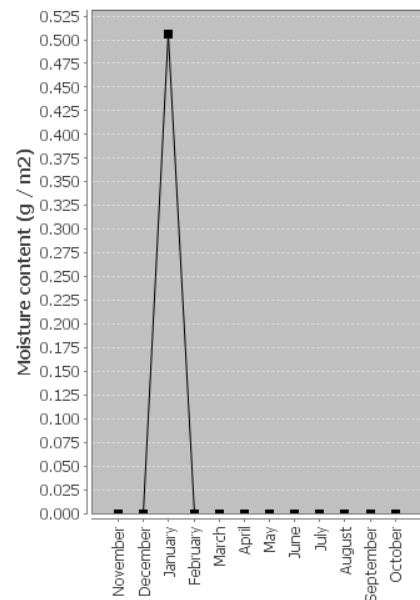
Ventilation cavity / Wooden cladding
